RNAV (GPS) RWY 5L

RICKENBACKER INTL (LCK)

RNP APCH.		MALSR

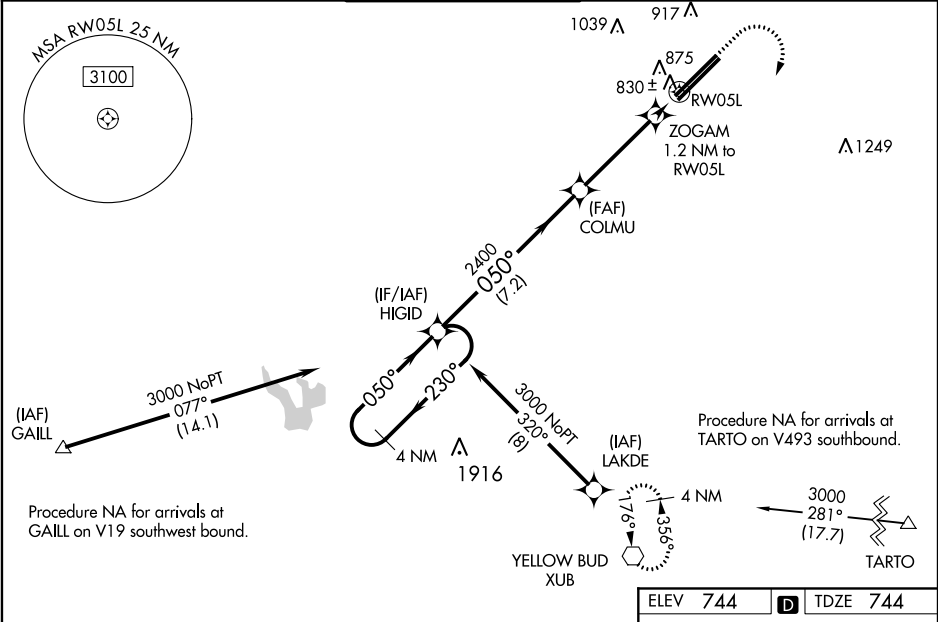
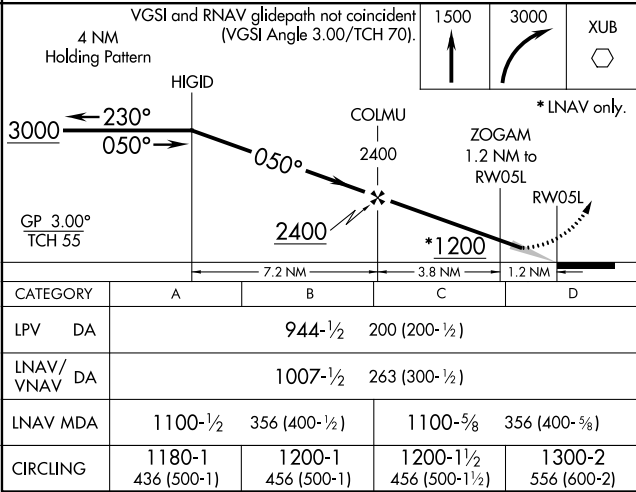
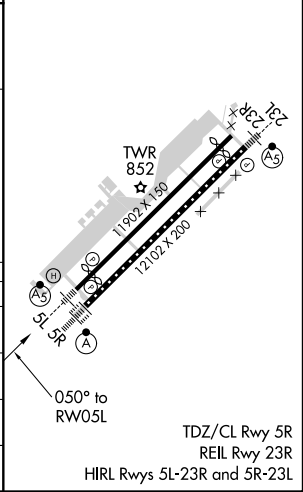
MISSED APPROACH: Climb to 1500 then climbing right turn to 3000 direct XUB VOR and hold.
Baro-VNAV NA when using John Glenn Columbus Intl altimeter setting. For uncompensated Baro-VNAV systems, LNAV/VNAV NA below -16°C or above 54°C. For inoperative MALSR, increase LNAV/VNAV all Cats visibility to ¾ mile. Circling NA northwest of Rwy 5L-23R. When local altimeter setting not received, use John Glenn Columbus Intl altimeter setting and increase all DA 36 feet, and all MDA 40 feet. Increase LNAV Cat C and D visibility ½ mile.				
ATIS <b>132.75</b>	COLUMBUS APP CON <b>134.0 279.6</b>	RICK TOWER <b>120.05 348.4</b>	GND CON <b>125.275 275.8</b>	CLNC DEL <b>125.275 275.8</b>
